ISS Inspection Capabilities and Challenges

NASA Johnson Space Center
Astromaterials Research and Exploration Science (ARES)
Image Science and Analysis Group (ISAG)
KX/Randy Moore
<http://isag.jsc.nasa.gov/>

July 2014

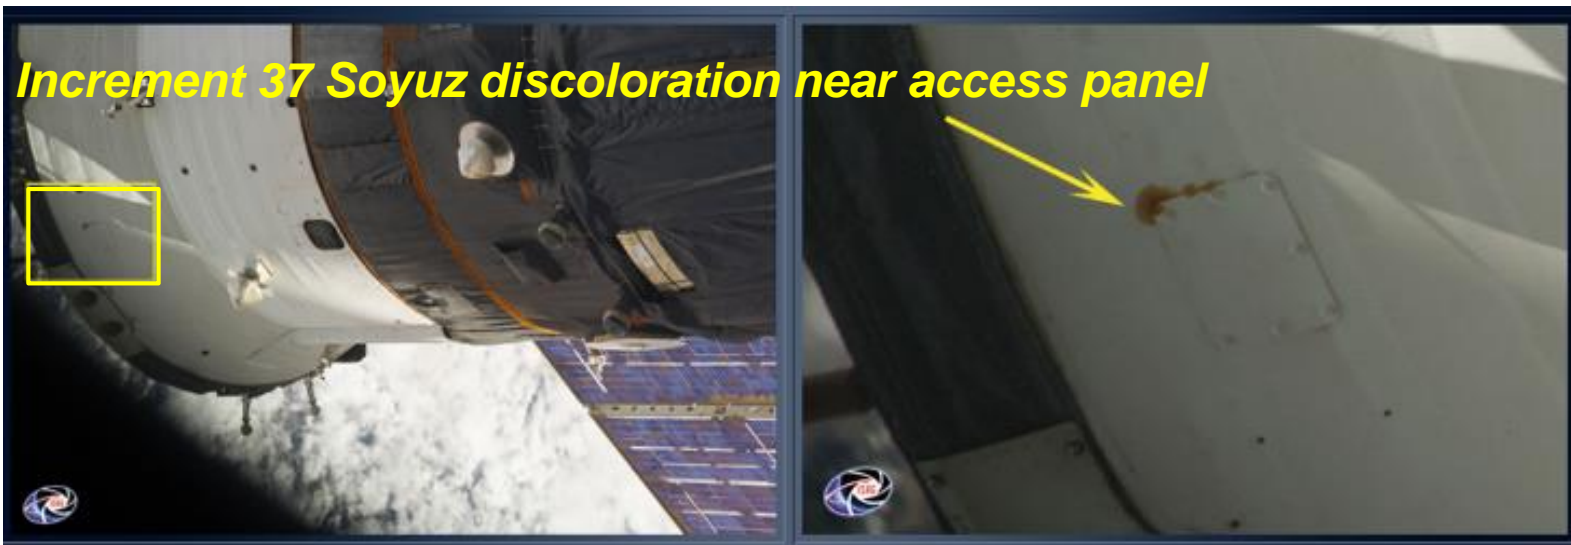
Increment 37 Soyuz discoloration near access panel

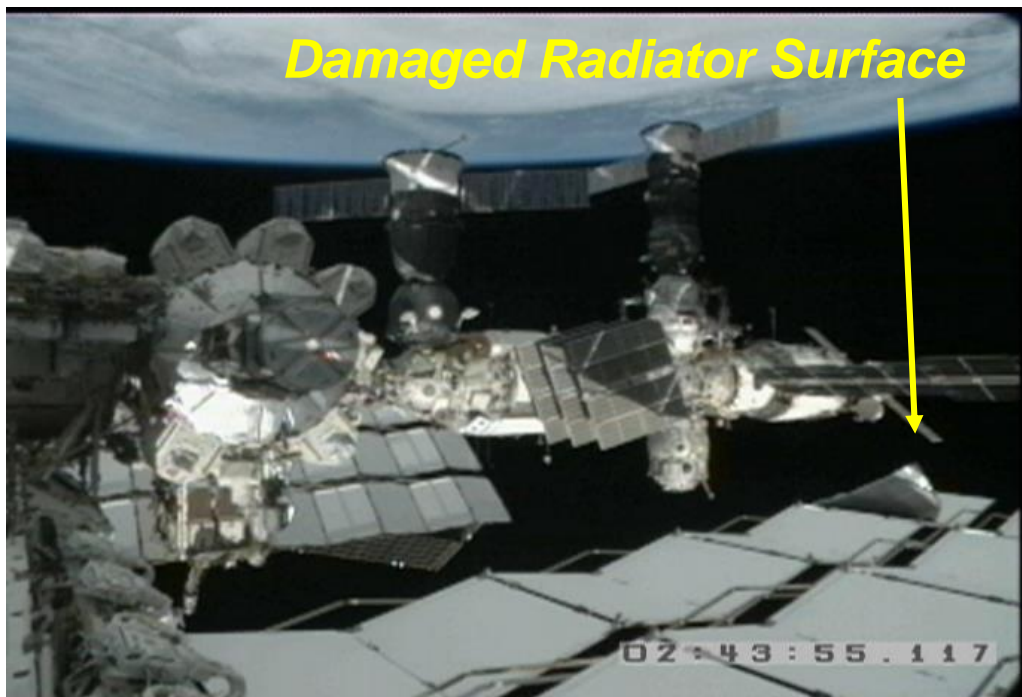
Damaged Radiator Surface

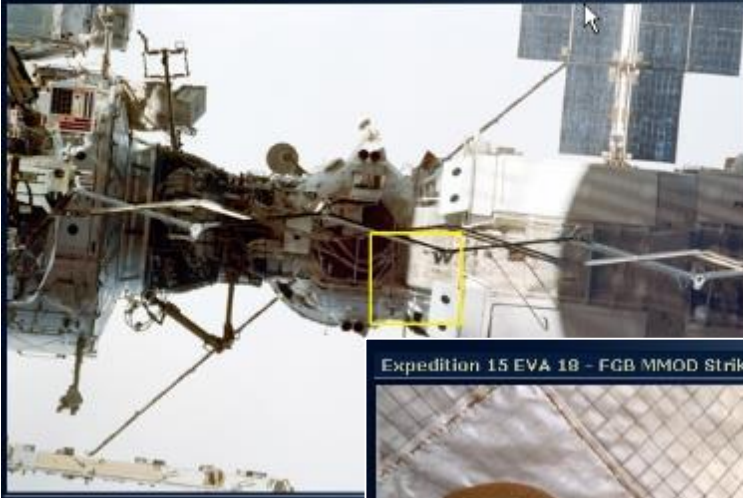
STS-114 Fly-Around Imagery - FGB Zenith Side

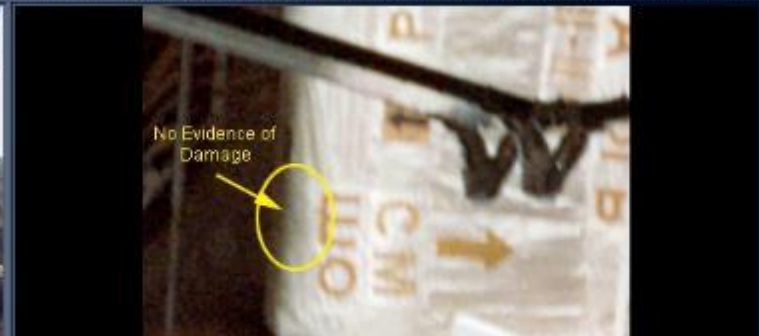
STS-114 Fly-Around Imagery - FGB Zenith Side (cropped, enhanced)

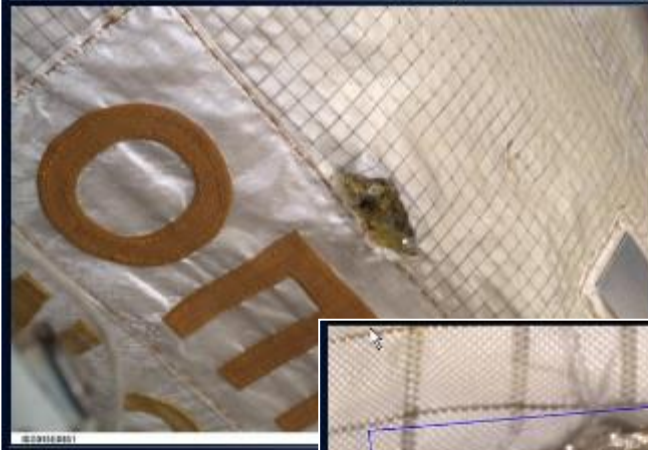
Expedition 15 EVA 18 - FGB MMOD Strike (Image ID: ISS015E10851)

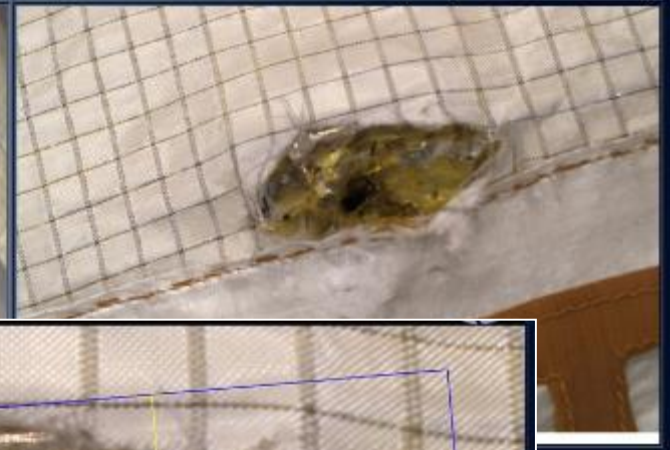
Expedition 15 EVA 18 - FGB MMOD Strike (Image ID: ISS015E10855)

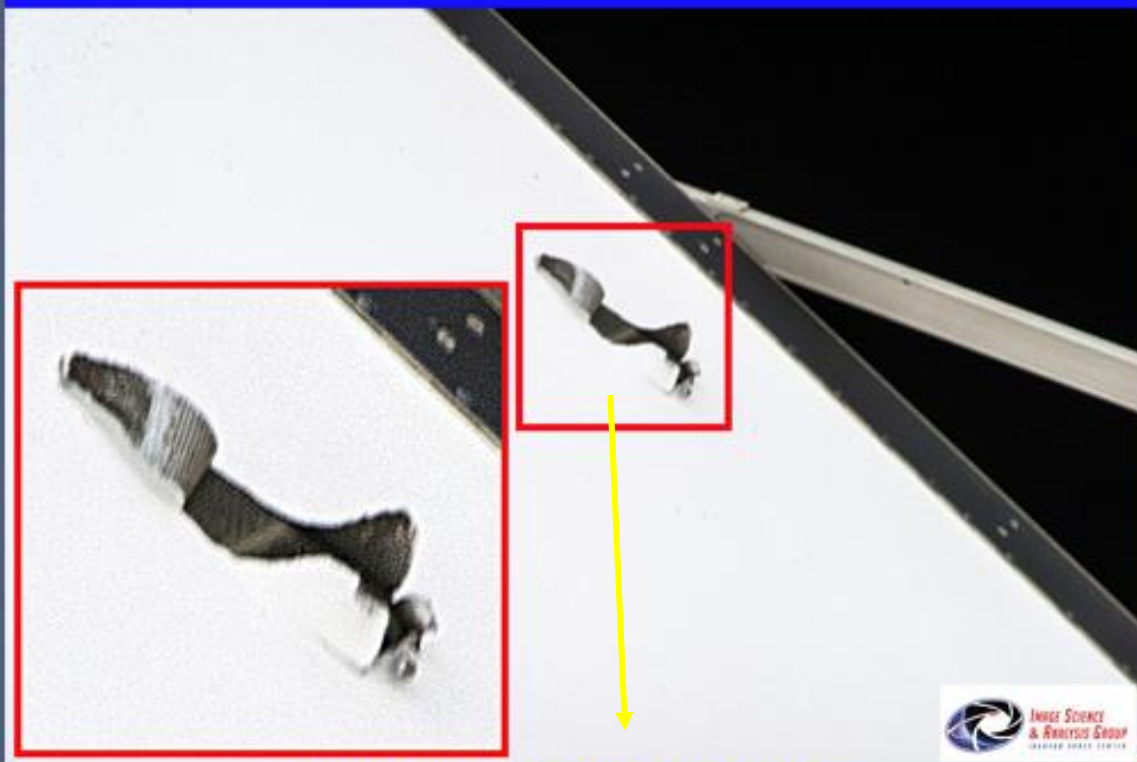
Radiator MMOD Strike

Digital Camera View of The "2A" Side of Panel 3, P4-PVR Radiator

Acquired with Nikon D3s Digital Still Camera Equipped with an 800mm Lens

Imagery Captured July 5, 2014, 186/19:19 GMT

The upturned edge of the cover sheet suggest that this is likely the the exit hole of a "through the panel" impact.

Out of focus appearance is due to wave front interference caused by shooting the photo though the scratch pane.

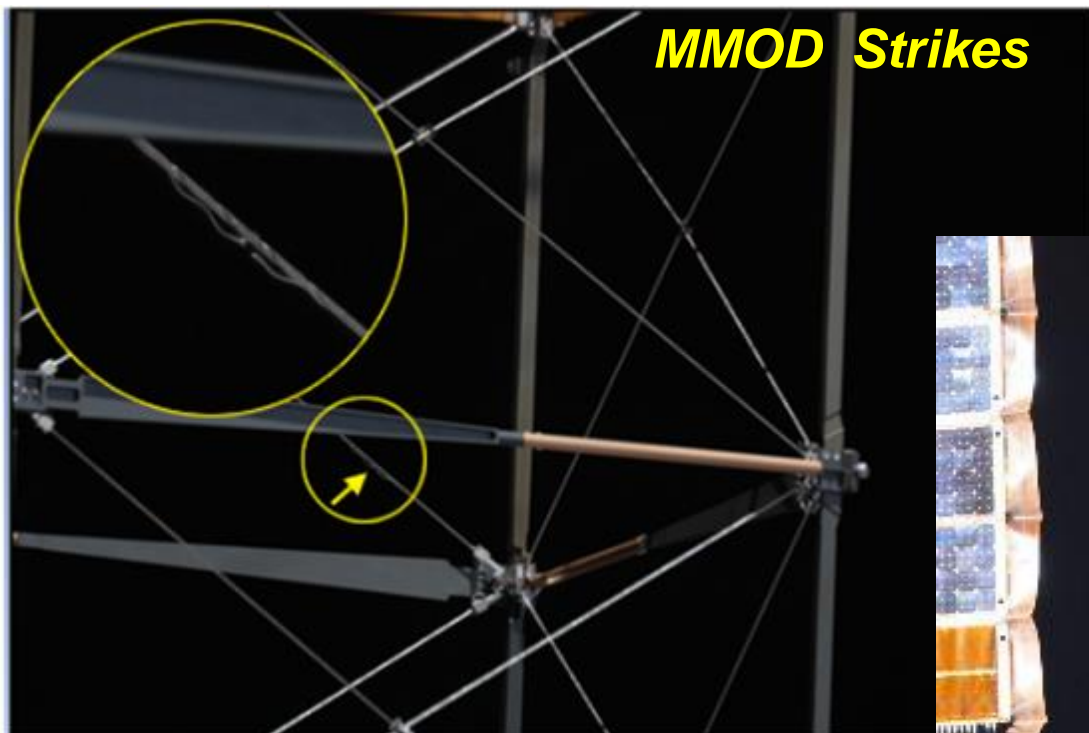
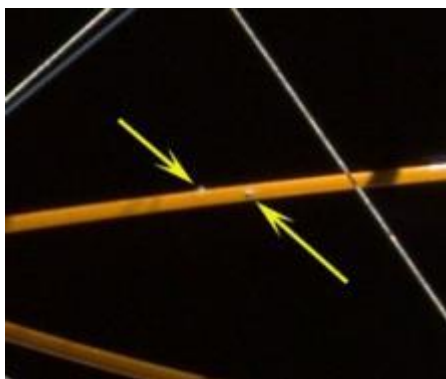
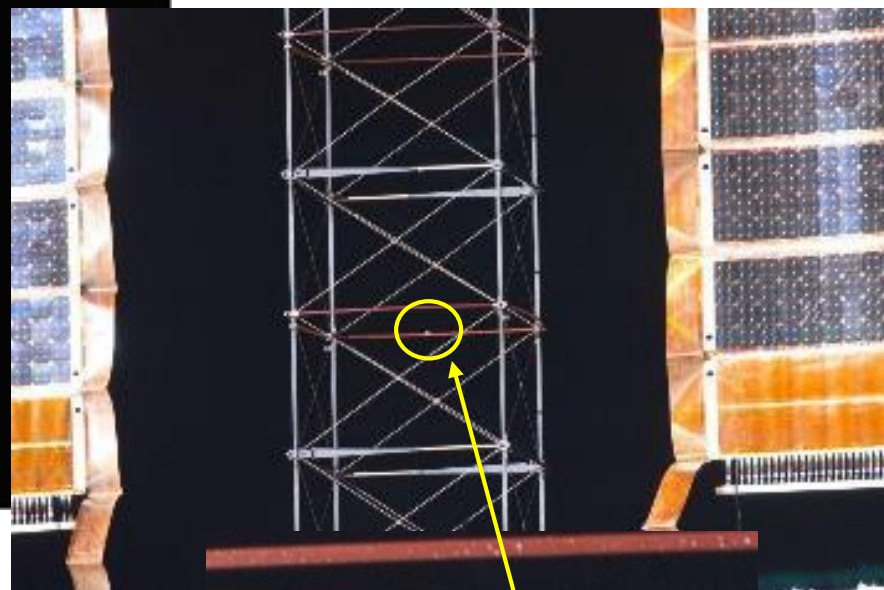
Photographic Survey of the P4 2A S/W Mast
STS-130/AF-20A Flight Day 11 850mm Nikon D2Xs
iss022e060922-iss022e06100 (Pass 2/2)

MMOD Strikes

0.61 +/- 0.03 inches

0.26 +/- 0.03 inches

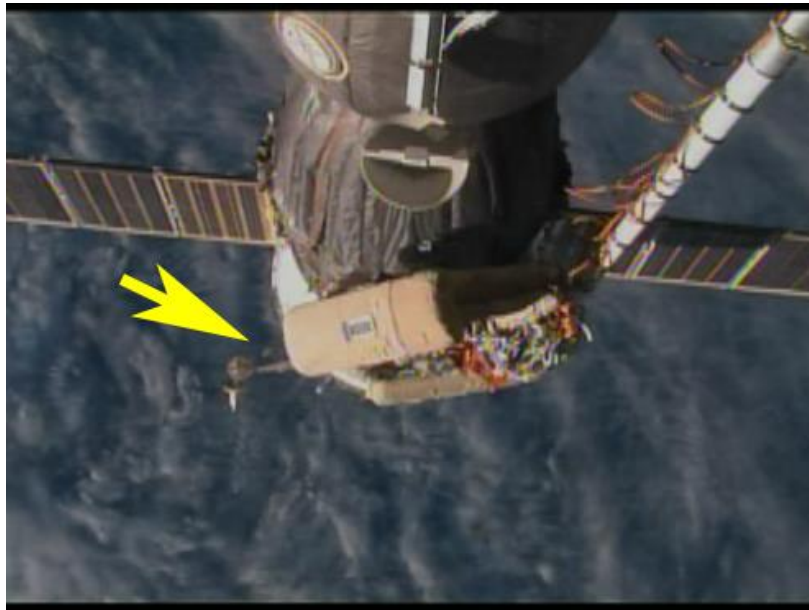
Foreign Object Debris

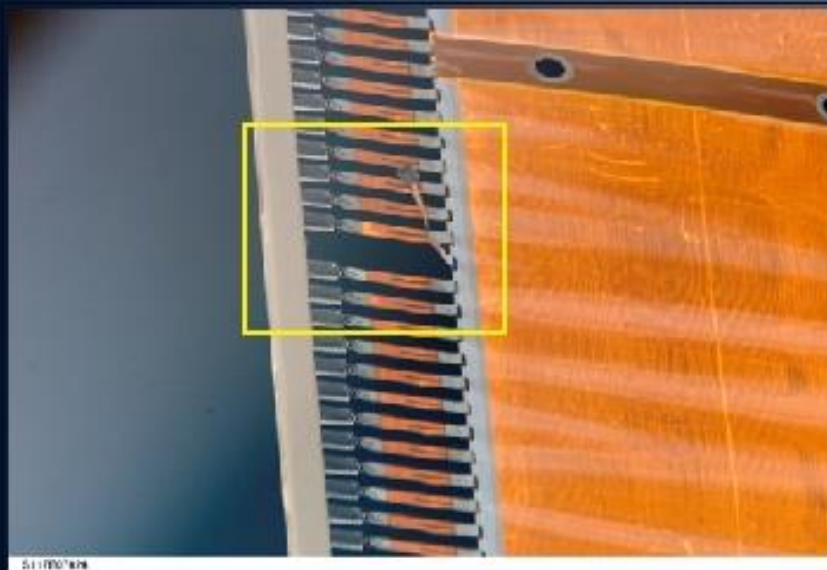
STS-117 EVA #2 Imagery of Separated 2B SAW Leader Panel

STS-117 EVA Image (s117e07024)

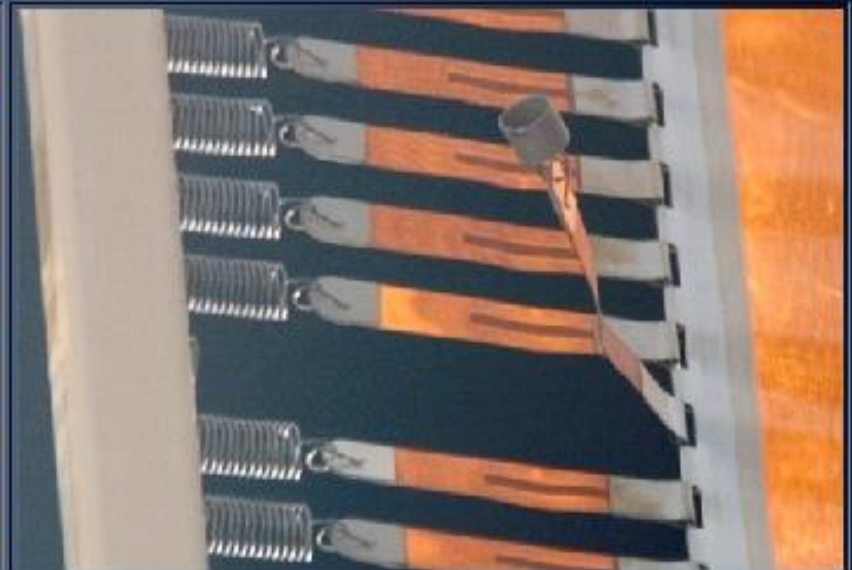
STS-117 EVA Image - Enhanced (s117e07024)

Separated Solar Array Leader Panel

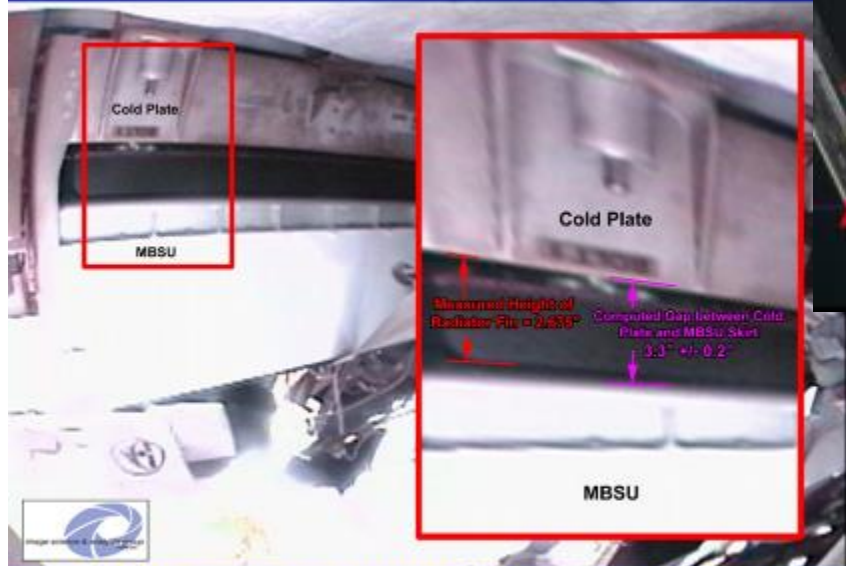
Analysis of Gap Between MBSU and Cold Plate

The following provides an estimate of the distance between the bottom of the skirt of the MBSU and the top of the Cold Plate.

These measurements were made from WVS imagery acquired immediately prior to Airlock ingress during US EVA 18 on 8/30/12.

Scale was based upon the known height of the radiator fins off the cold plate surface which were measured on a flight-like unit on 8/31/12 by IS&AG personnel.

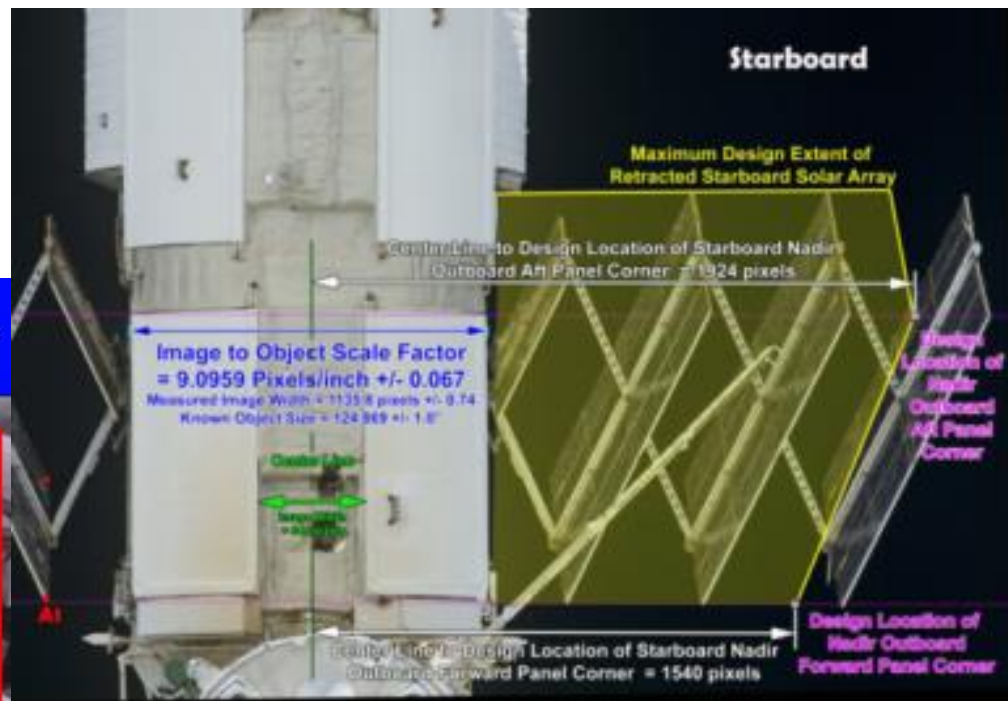
**Installation gap measured from
EVA helmet video**

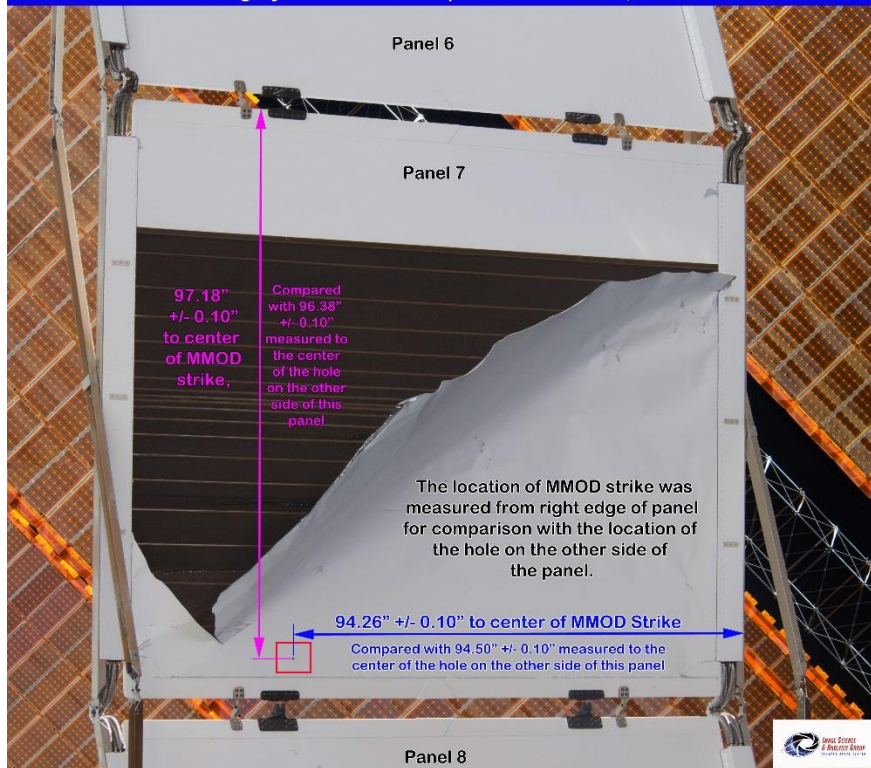
Comparison of MMOD Strike Location on Front and Back of S-TRRJ HRS Radiator S1-3, Panel #7
Imagery from Periodic Inspection on June 28, 2013

Mosaic of Panel 7 from iss036e012822 and 012823.
Analysis by Projective Plane to Plane Transformation, based on HRS radiator panel dimensions from Loral assembly drawing #83-39411.
Analysis by D. Liddle 7/29/13 Rev. 1.0

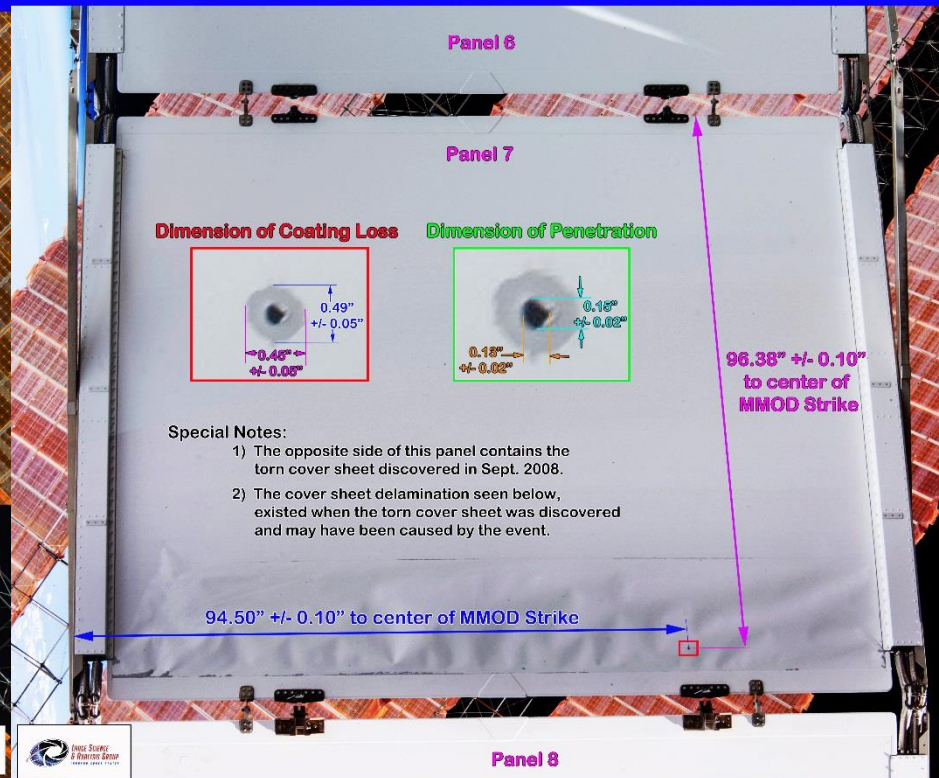
MMOD Strike on S-TRRJ HRS Radiator S1-3, Panel #7
Imagery from Periodic Inspection on June 28, 2013

- 1) The opposite side of this panel contains the torn cover sheet discovered in Sept. 2008.
- 2) The cover sheet delamination seen below, existed when the torn cover sheet was discovered and may have been caused by the event.

Mosaic of Panel 7 from images iss36e012933 and 012935, with insets from iss036e012961.
Analysis by Projective Plane to Plane Transformation, based on HRS radiator panel dimensions from Loral assembly drawing #83-39411.
Analysis by D. Liddle 7/26/13 Rev. 1.0

Photogrammetric measurements of thermal radiator panel damage and MMOD strikes

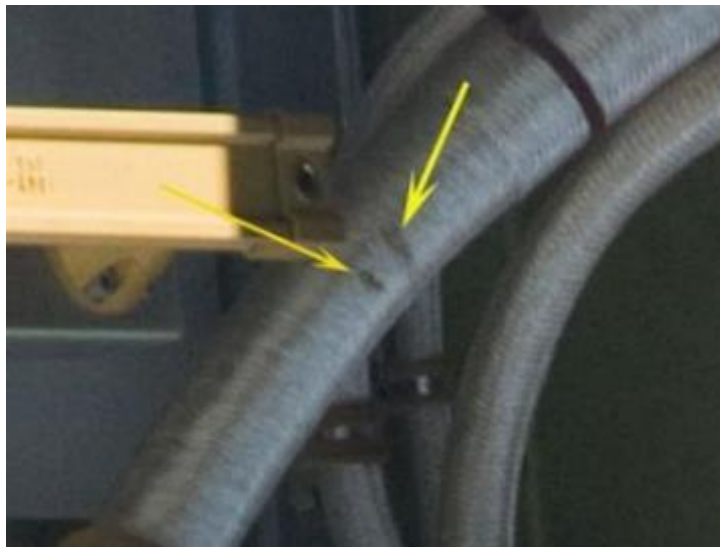
***Wire Harness Survey for S4
Electrical Anomaly***

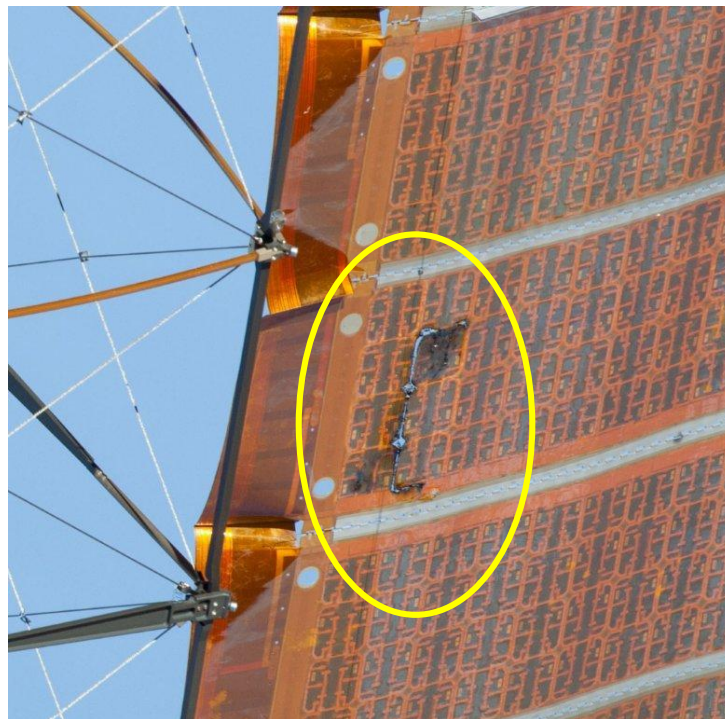
***Solar Array Survey for S4
Electrical Anomaly***

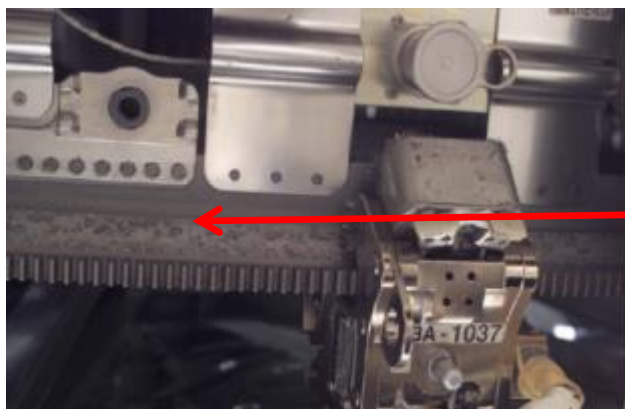
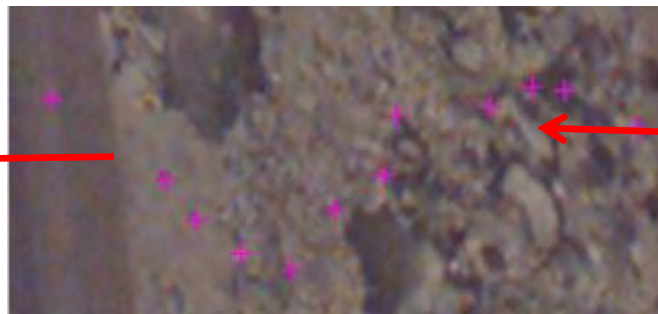
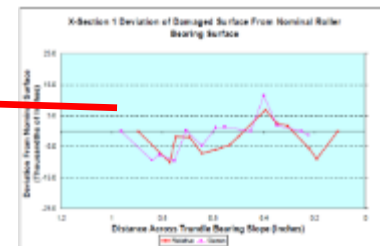
SARJ Roller Bearing Surface Damage

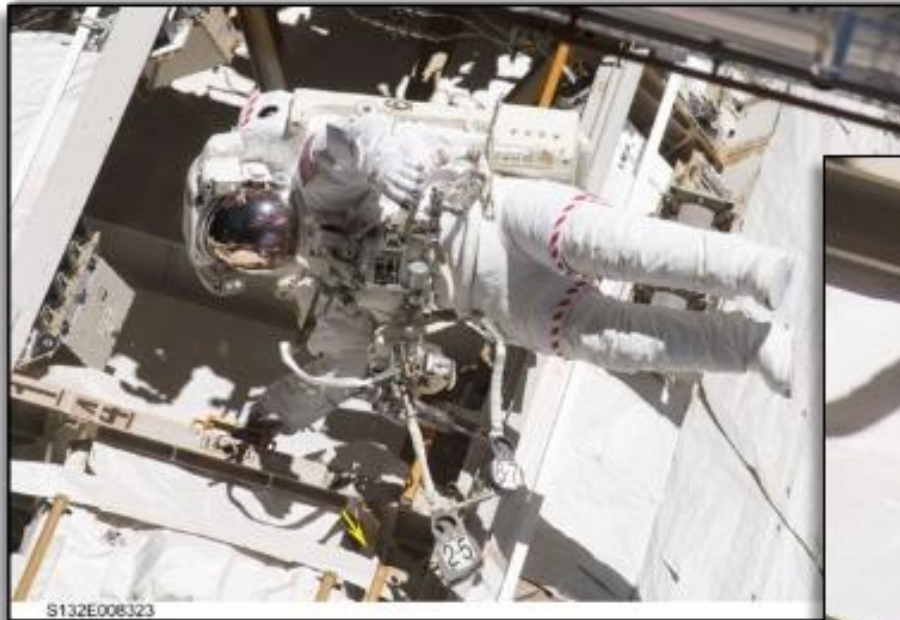
EVA Sharp Edge Inspection

Potential MMOD Strike
P1 Truss Bay 12
Adjacent to Handrail

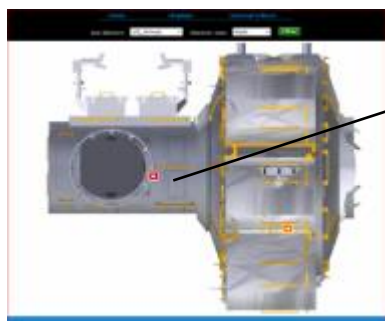
ISS Airlock Hand Rail Possible MMOD Strike

Preliminary Results of Dimensional Analysis

Lip height above Nominal 0.01 +/- 0.005 inches
Crater Depth below Nominal 0.05 +/- 0.03 inches

0.07" Outer Diameter
0.05" Inner Dia.
Diameter varies by +/- 0.01 inches due to irregularities in the shape

IS&AG Measurements based on convergent and stereo photogrammetric analysis of photography taken on EVA 3 using the hand rail mounting bracket to scale the measurements.
By Don Liddle and Orrin Thomas (JSC-Image Science and Analysis Group)

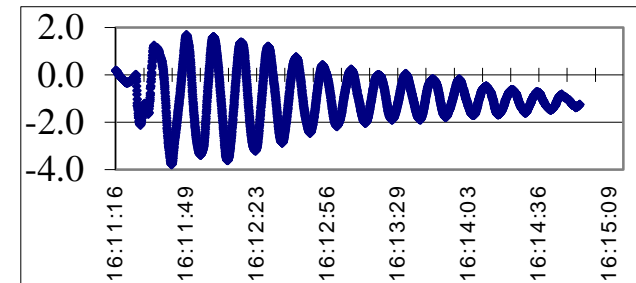
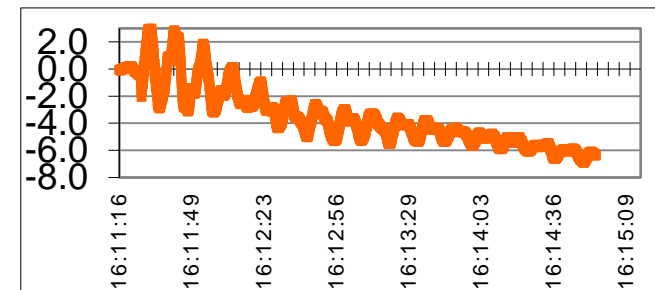
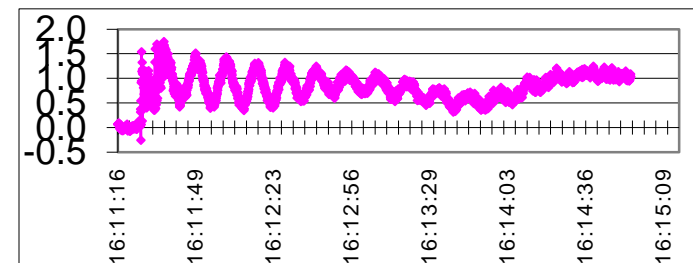
Tracking motion of solar array response to thruster firings

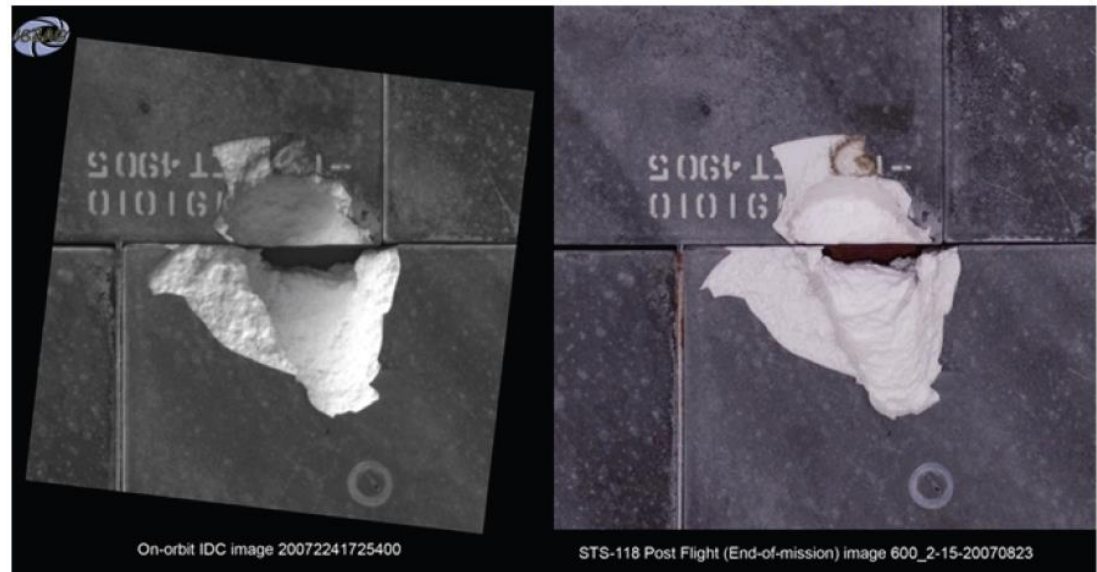
STS-118 Shuttle TPS Damage

On-Orbit Measurements:
For RPM Measurements, click [here](#).
(Uncertainty: +/- 0.15")

Post-Flight Measurement: 3.45" x 2.66" (ISAG)
(Measuring in the same direction as on-orbit,
Length - 3.35", Width - 2.44")

On-orbit IDC image 20072241725400

STS-118 Post Flight (End-of-mission) image 600_2-15-20070823

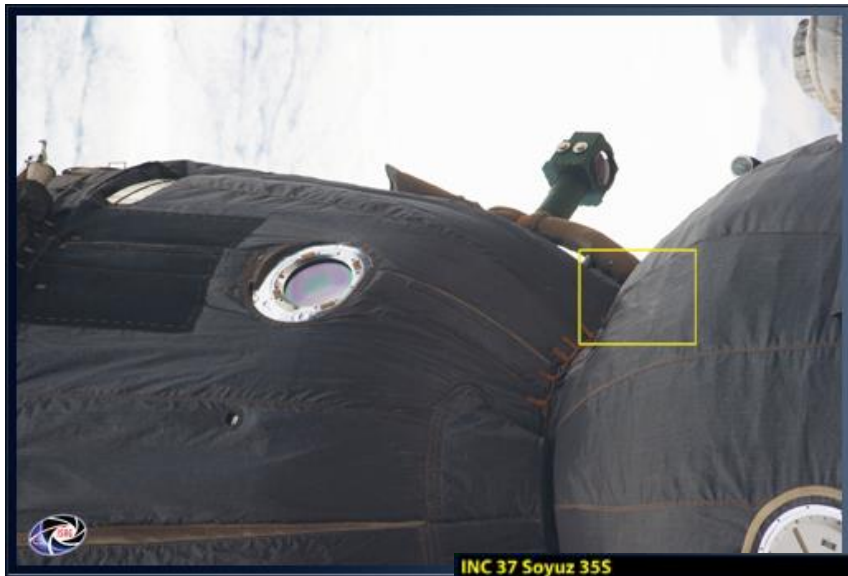
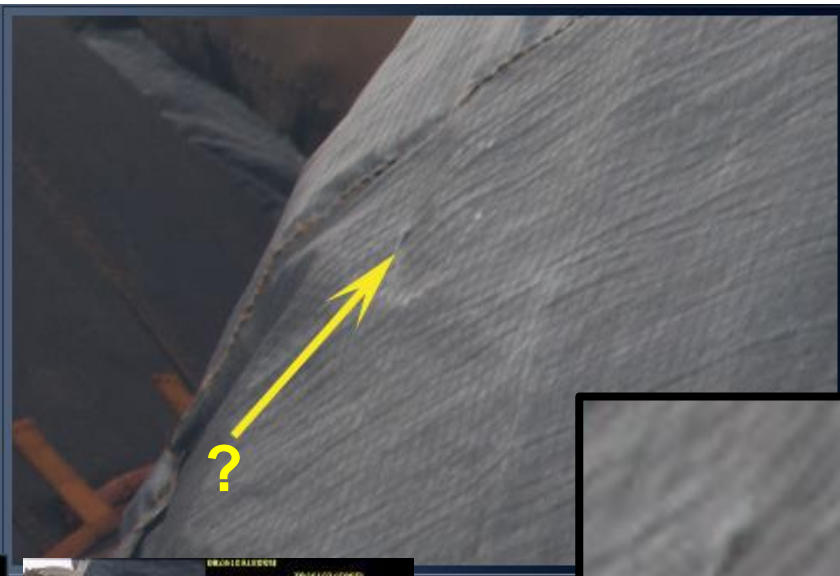
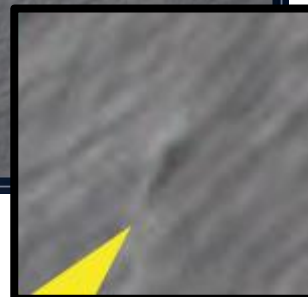
INC 37 Soyuz 35S
Cupola W5
D3s w/180mm lens
October 25, 2013

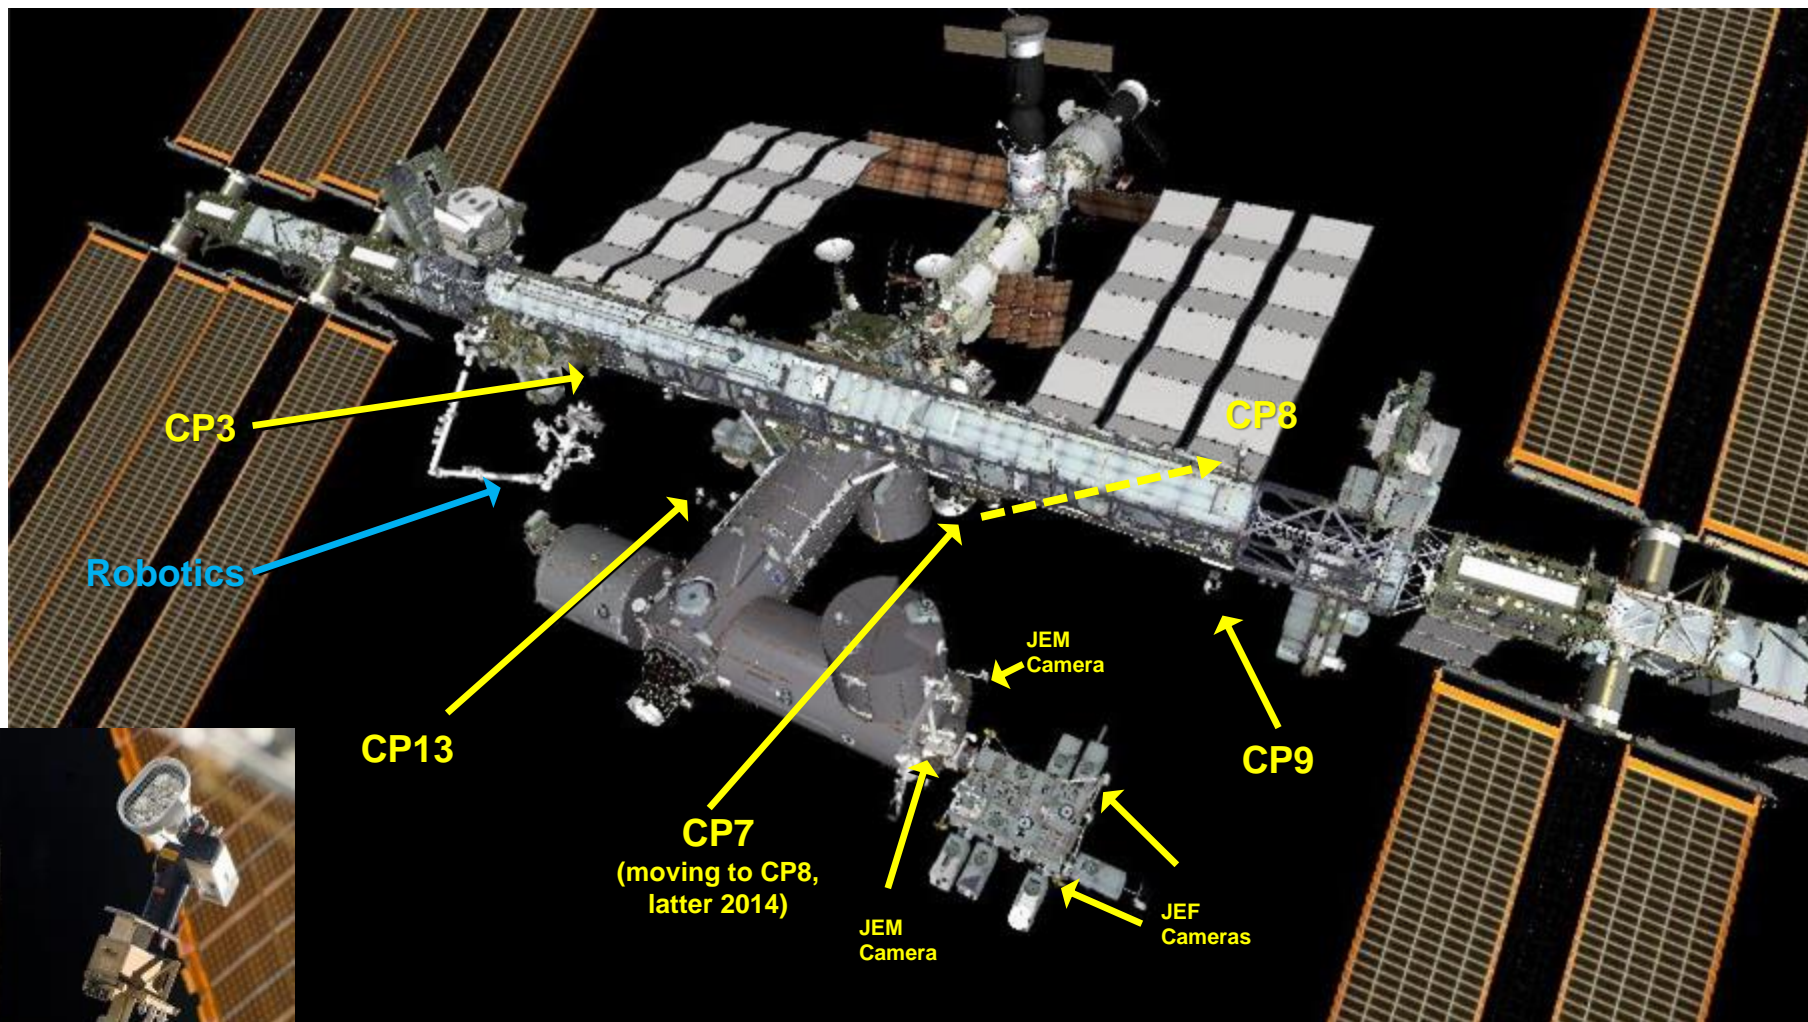
External ISS Television Cameras

ETVCG – External TV Camera Group (4)
NTSC, 525 horizontal lines (USOS Standard)
CCD sensor
FOV: Max: 77x61 Min: 10x8°
Zoom ratio ~8:1

**JEM EF – JAXA Experiment Module
Exposed Facility**
NTSC, CCD

Note: High Definition Video/Still DSLR/zoom lens to be attached to each ETVCG beginning 2015

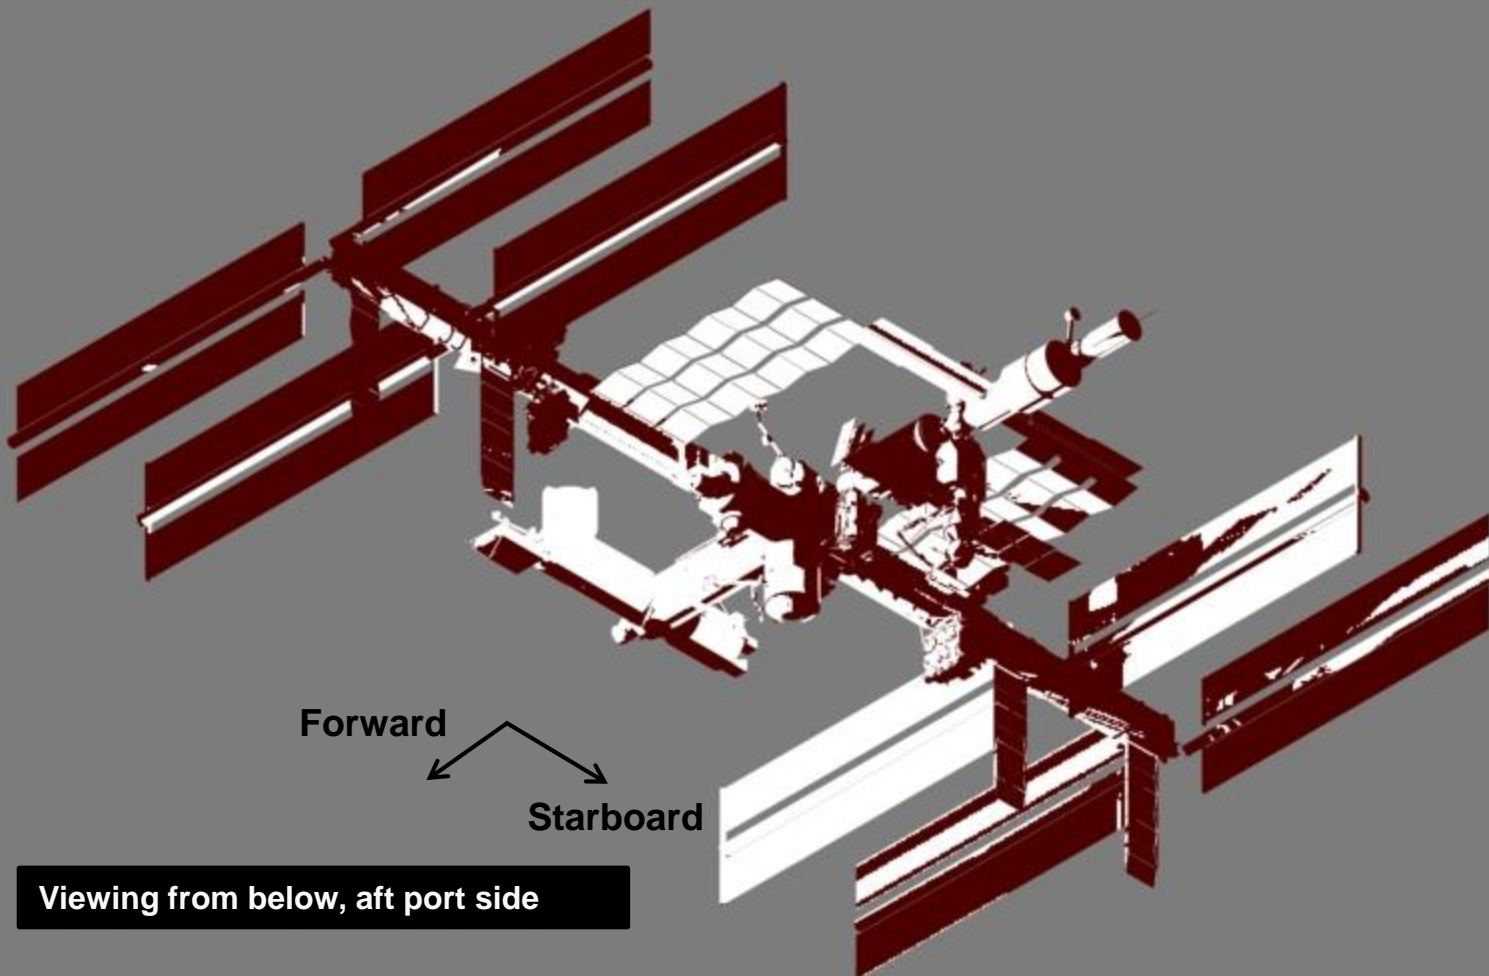
External TV Camera Coverage (ETVCGs (4) + JEM (4))

Brown shading shows current ETVCG and JEM cameras
“blind spots”

Viewing from below, aft port side

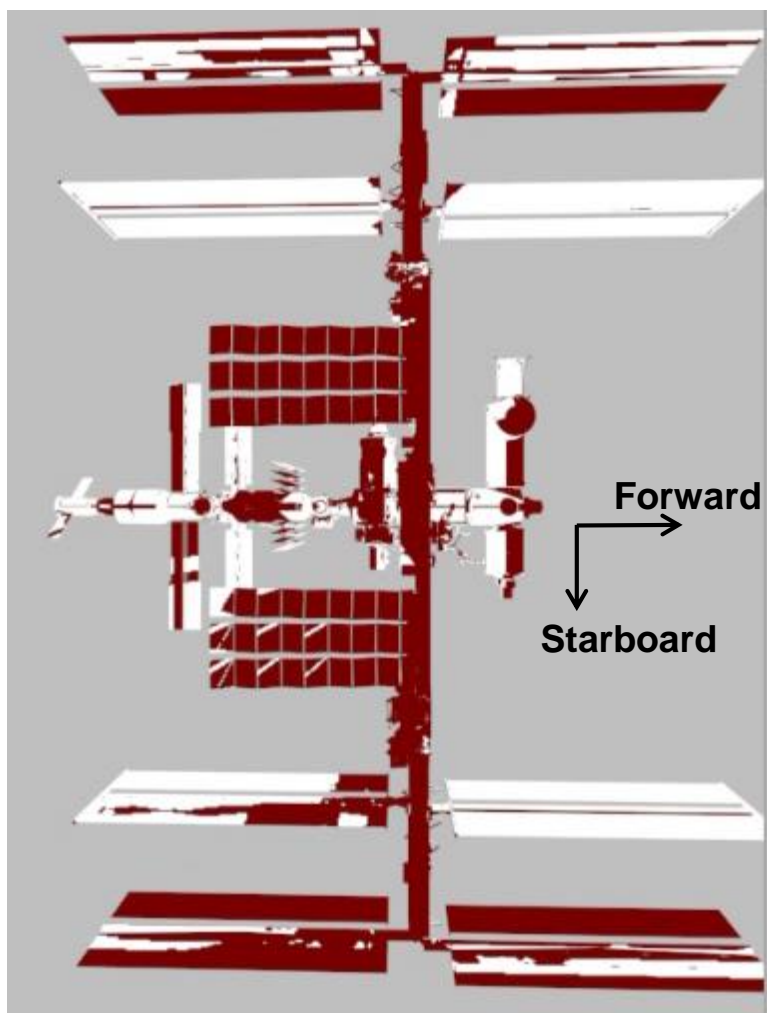
Viewing from above

Brown shading shows current ETVCG and JEM cameras “blind spots”

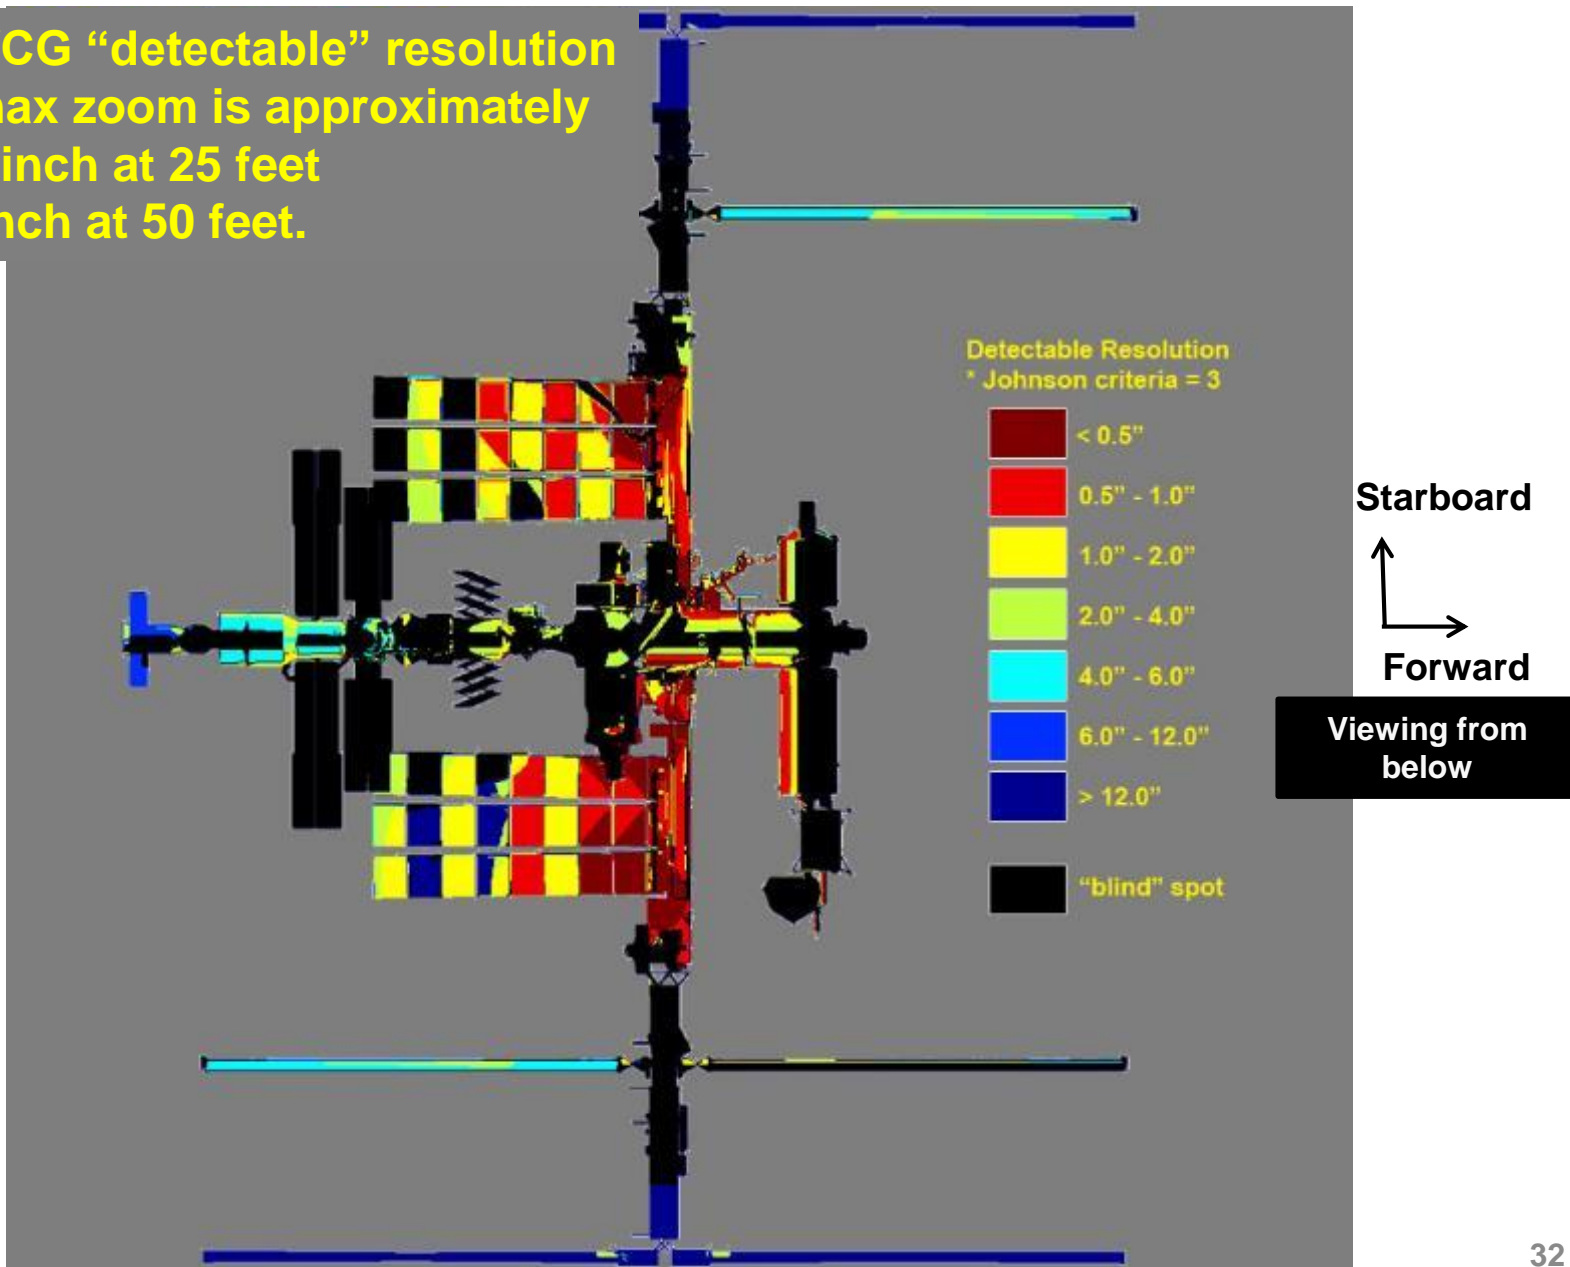
External TV Cameras Resolution Analysis

All ETVCGs Combined (4)

ETVCG “detectable” resolution
at max zoom is approximately
.25 inch at 25 feet
.5 inch at 50 feet.

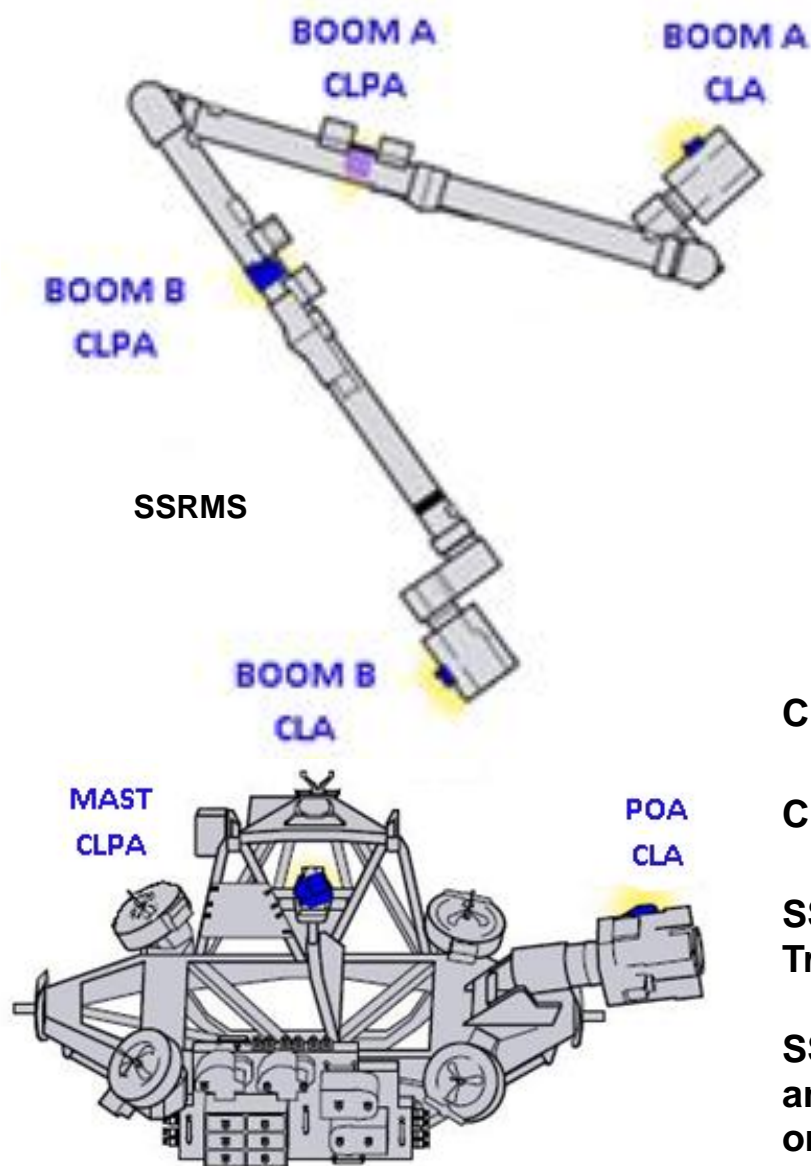
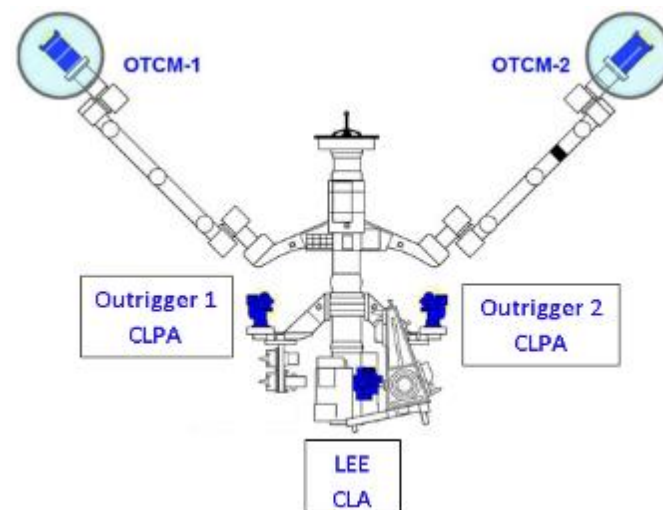
External Television Cameras (Mobile Servicing System)

SSRMS

Mobile Base System

Special Purpose Dexterous Manipulator
(SPDM)/DEXTRE

SSRMS moves along truss when attached to Mobile Transport/Mobile Base System (MT/MBS).

SSRMS is operational along truss at MT Worksites and Power and Data Grapple Fixtures (PDGF) located on USOS modules and Russian FGB.

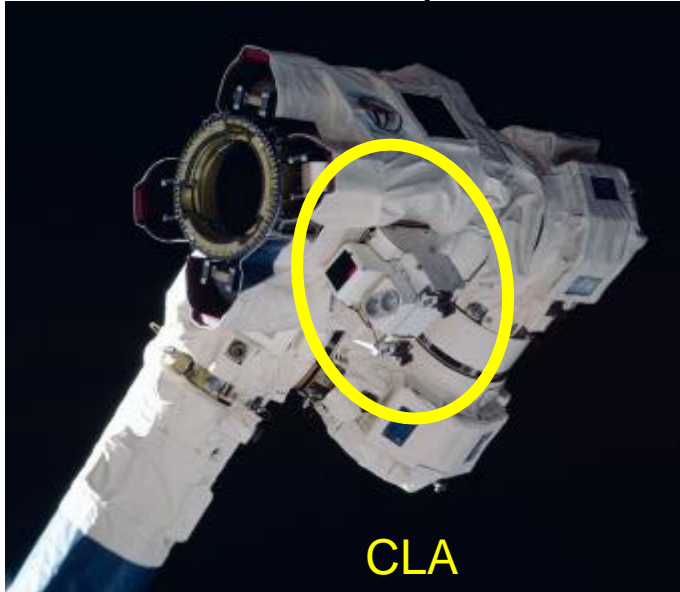
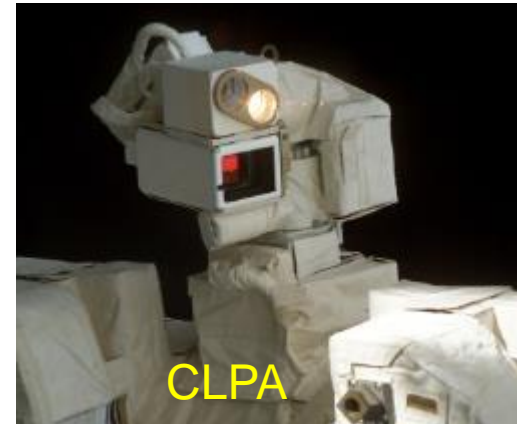
External Television Cameras (Mobile Servicing System)

- Both CLA and CLPA utilize the same CCD camera and lights
- FOV Max ~ 52° x 40°, ~9mm focal length,
Min ~ 6°x4° , ~84mm focal length
- Zoom ratio ~9:1
- The minimum viewing distance is 14 in.
- MSS camera “detectable” resolution at max zoom is approximately
 - ~.2 inch at 25 feet
 - ~.4 inch at 50 feet.
- Standard ETVCG and MSS frame rate: 30 fps
